**REPORT CONCERNING THE AFFECTS OF ABANDONED  
UNDERGROUND COAL MINING ON THE BLACKHAWK RANCH**  
Filing No. 3

**Huerfano and Las Animas Counties, Colorado**

Carlton E. Gerity, P.E.

November 1996

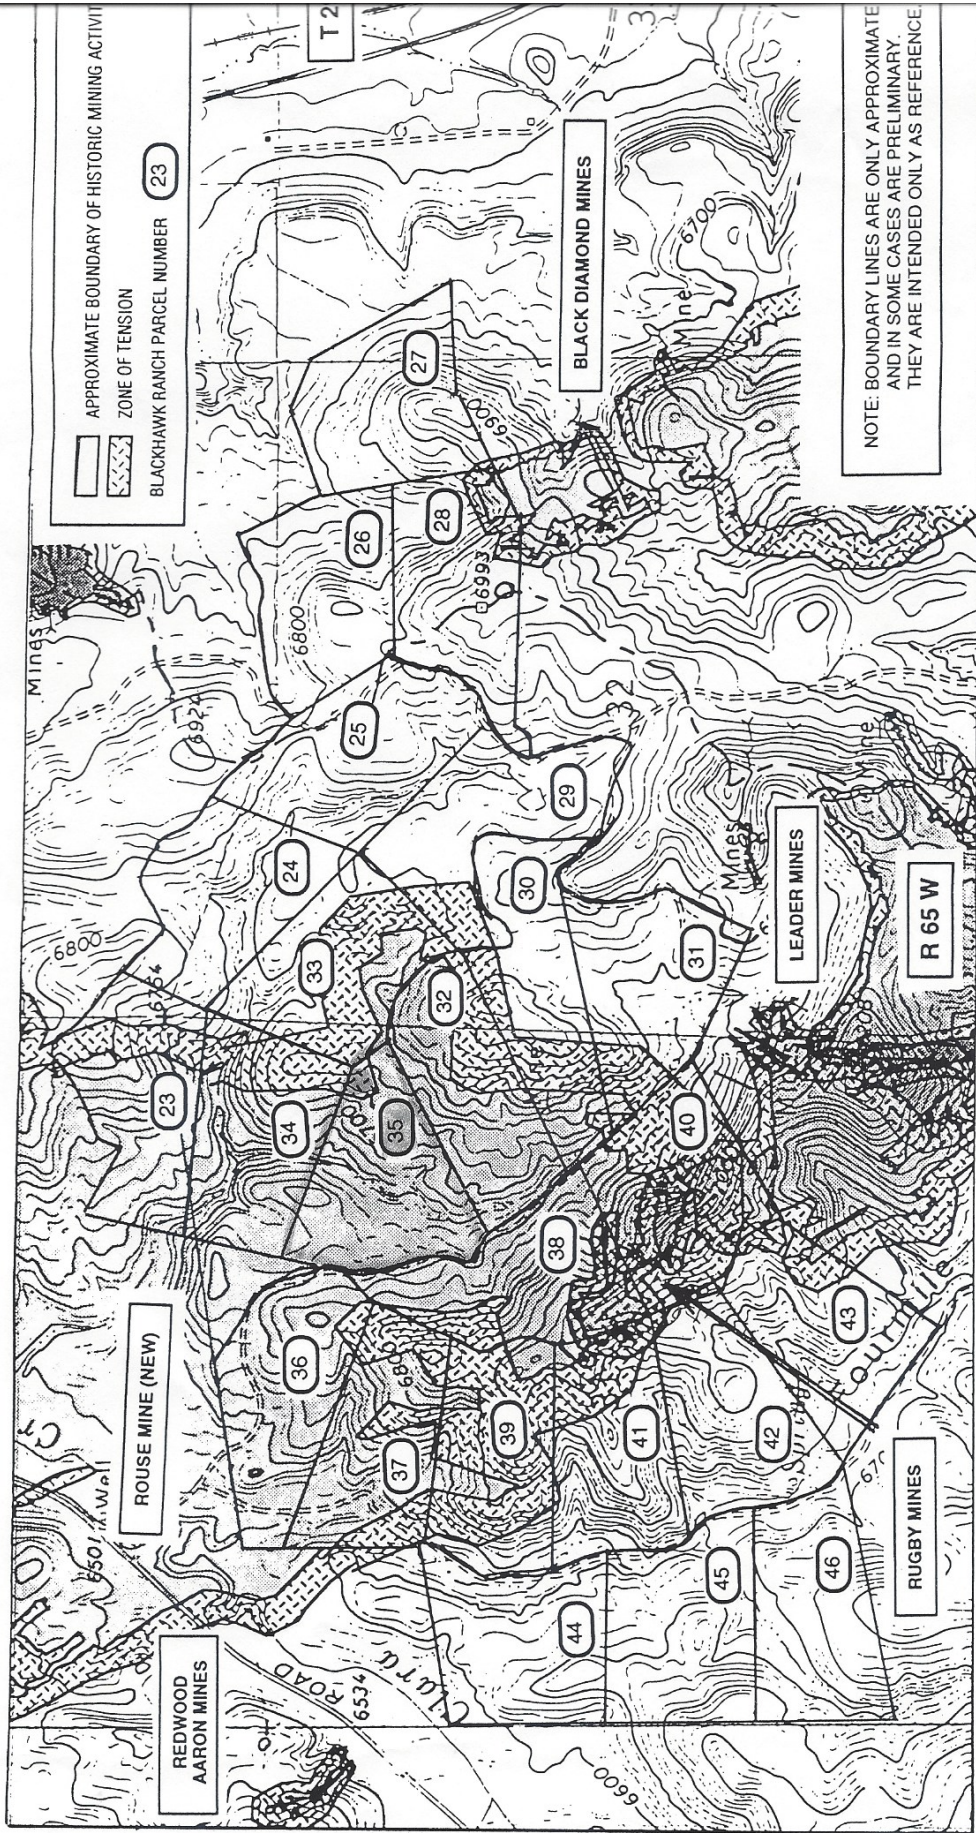
TITLE BLACKHAWK RANCH FILING #3  
 MAP 1: POTENTIAL SUBSIDENCE ZONES  
 LOCATION OF HISTORIC UNDERGROUND COAL MINING

The mines were underground and ranged in depth from 0 feet at the portals or mine entrances along the eastern sections of the mine, to about 200 feet in the northwestern sections of the mine. Map 1 shows the relationship between the mine workings and the subdivision parcels. Parcels 27 and 28, would be the only areas potentially affected by any subsidence from this mine's workings, they are located along the northern portions of this mine. The site visit determined that there is no visual evidence of any mine subsidence in the area.

The mine was underground and ranged in depth from 0 feet at the portals in the Northeast corner on Section 30, to about 2000 feet along the west and southwest. This mine underlies Parcels 23, and 29 to 41. (See Map 1). There is no visual evidence of any mine subsidence in the area. This mine is very deep under this filing and there are other mines that overlie these workings in shallower coal seams

The Rugby Mines are located in Section 31, T29S, R65W. They operated from 1898 to 1924, from 1935 to 1936, and from 1945 to 1954; from coal seams that were from 3.0 to 3.9 feet thick. The mines were underground with a listed production of 1,275,000 tons. They ranged in depth from 0 ft. at the portals in the east to 200 ft to the west. These mines underlay Parcels 38, 40, 41, and 42. There is no evidence of subsidence over these mines.

The Leader Mines are located in Section 31, T29S, R65W. th Leader #1 and #4 operated from 1920 to 1933. The Leader #2 and #3 operated from 1932 to 1946, from 1952 to 1956, and from 46 to 1960; from coal seams that were 3.0 feet thick. The mines were underground and had a listed production of only 134,000 tons. They ranged in depth from 0 ft. at the portals in the east to 250 ft to the west. These mines underlie Parcel 43. There is no evidence of subsidence over these mines.

Around the edges of the mining area is a zone of tension that presents the most serious problem for foundation design, this is an area where there is a transition from stable ground to subsiding ground. It is very likely that the effects of subsidence occurred years ago, and that there is no ongoing problem, designs to protect against failure in this zone are well understood and relatively inexpensive. The easiest way to avoid any problems would be to locate any structures away from the edges of the mining zones, or by orienting structures along the edges of these zones.
